# Manhole Inspection Summary

Manhole # S29WW\_004MH

Insp Date: **5/16/07 12:01 PM**

**Location** Address: **3222 KESWICK RD**

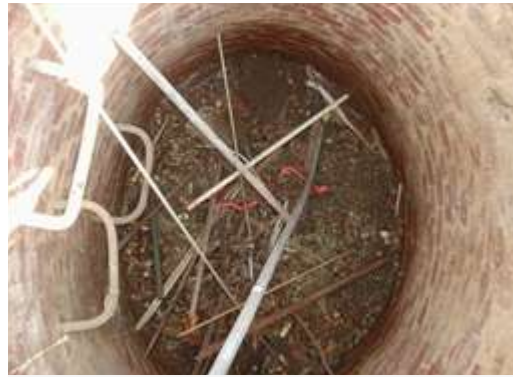
Top View

Barrel infiltration. Channel debris.

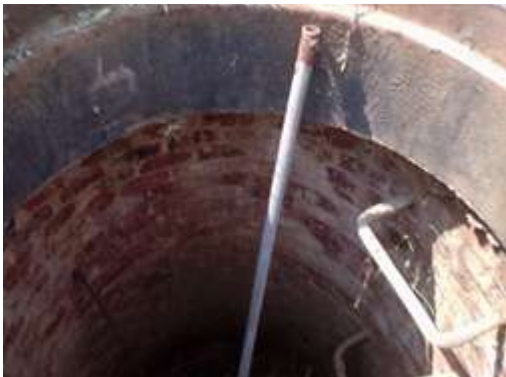
Defect

Frame leaks. Adjustment infiltration - other side.

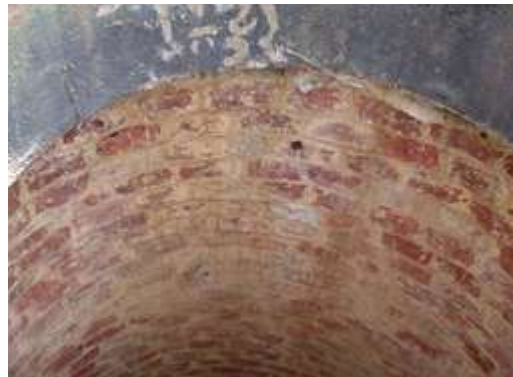
Defect

Frame leaks. Adjustment infiltration.

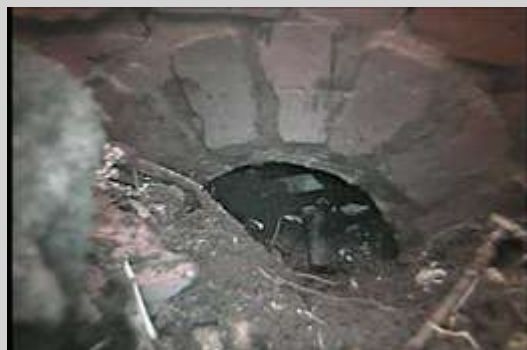
Pipe Out @ 12 O'Clock

Deposits: ☐ None ☒ **Mud** ☐ Sludge ☒ **Debris** ☐ Grease

Silt Depth: **8** (in.)

Deposits Extent: **Heavy**
